## Characterization of MX Upper Stage Subscale Carbon-Carbons

Materials Sciences Laboratory  
The Ivan A. Getting Laboratories  
The Aerospace Corporation  
El Segundo, Calif. 90245

11 March 1977

Interim Report

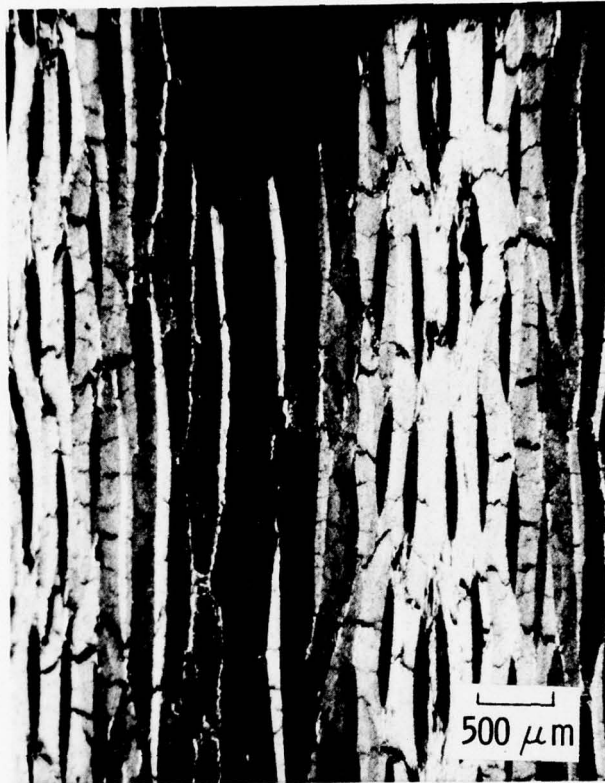
Figure 62. Throat Support SN002 Metallograph Location 2 (500 μm)

As mentioned in the preceding section, the erosion pattern of throat support SN002 was very similar to that of SN001. The photomicrographs of SN002 were taken to be complementary to SN001. Figure 61 shows the overall cross section of throat support SN002 after test. Figures 62 and 63 are photomicrographs taken along the fired surface. Figure 64 illustrates the weave structure at 90 deg to the fired sections. The sawtooth erosion pattern is again very evident. In this case, the peaks and valleys do not coincide with the reinforcement direction, as noted for throat support SN001. Figure 63, taken in slightly off cross-polarized light, dramatically illustrates the lack of systematic repetition of the light and dark patterns. This fact supports the hypothesis that fabrication condition rather than weave geometry is driving performance of these parts. Figures 65 and 66 are photomicrographs of the fired surface at location 1 (see Fig. 51). They show a structure quite similar to throat support SN001.

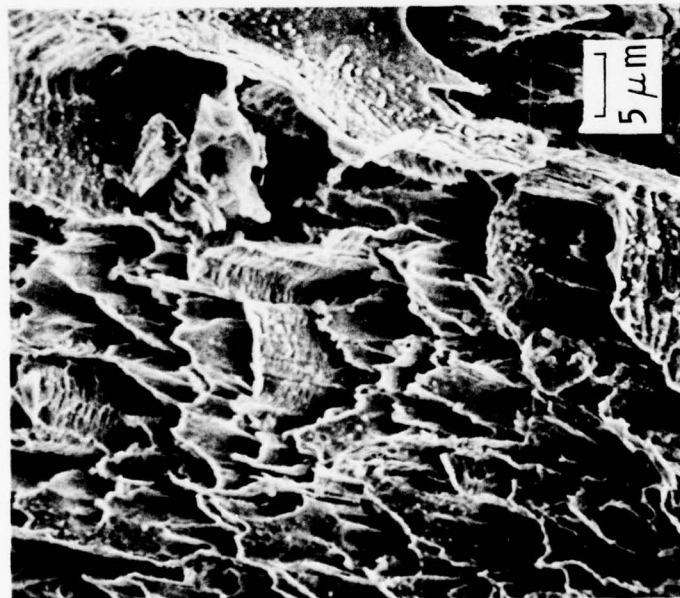
Figure 67. Throat Support SN002 SEM  
Location 1 (5 μm)

Figures 67, 68, and 69 are SEM photomicrographs taken at areas 1, 2, and 3 of the exit surface. These photographs illustrate an interesting feature common to all locations of the exit surface. In each case, the reinforcement has been removed to a significantly greater depth than the matrix. Although insufficient data exist on which to base a conclusion, efforts to find the cause of this phenomenon will be continued. Intuitively, this phenomenon seems inconsistent with a mass removal mechanism that is predominantly thermochemical. Determining the casual relationship between these materials, i.e., the matrix-reinforcement combination, and their response may be a key element in pinpointing performance.

Figures 67-69 also show the presence of a foreign element or compound that exists in the form of microspheroids that are randomly distributed along the surface of the matrix. A high magnification photomicrograph of one sphere (Fig. 70) indicates the smooth nature of the material. This quality, coupled with the location at the peaks of the residue matrix,
